My name is Kelly McFadden and I am a candidate for the PIPOA Board.

Our 32 mile bulkhead system is made up of five components:

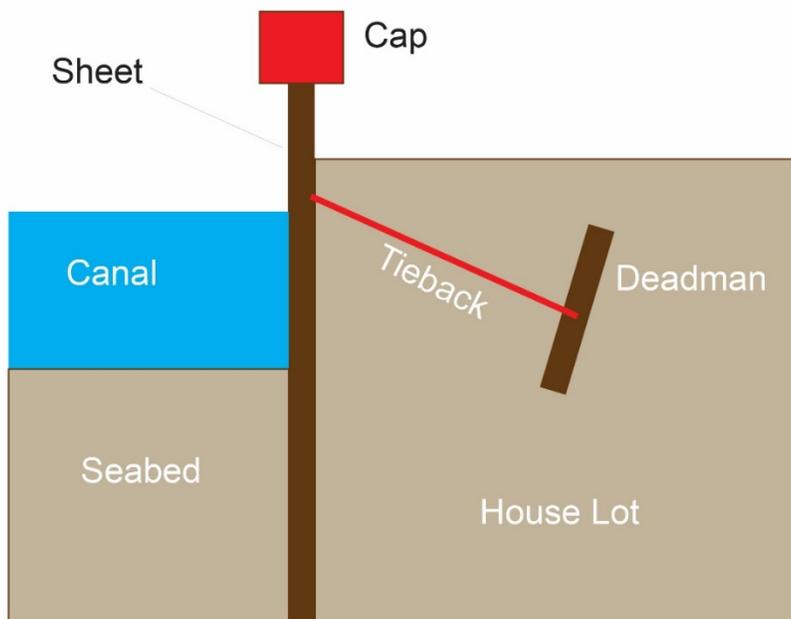
Let's start this discussing with some pictures and numbers. This picture is a diagram I created of my understanding of our bulkhead system. These are not engineering diagrams but are for illustration purposes only. Our bulkheads consist of concrete sheets, held in place by tie-backs connected to deadman posts. All covered with a concrete cap.

Behind each sheet, about 8 to 12-foot back is at least two deadman posts. I estimate that we have around 34,000 deadman posts in our system.

And from each sheet there is a tieback connecting the sheet to the deadman post. This is a steel rod, covered in pvc, that connects the sheet to the deadman post. This tieback is critical. This is what keeps our sheets from tipping forward and falling into the canal. I estimate we have around 34,000 tie backs to maintain.

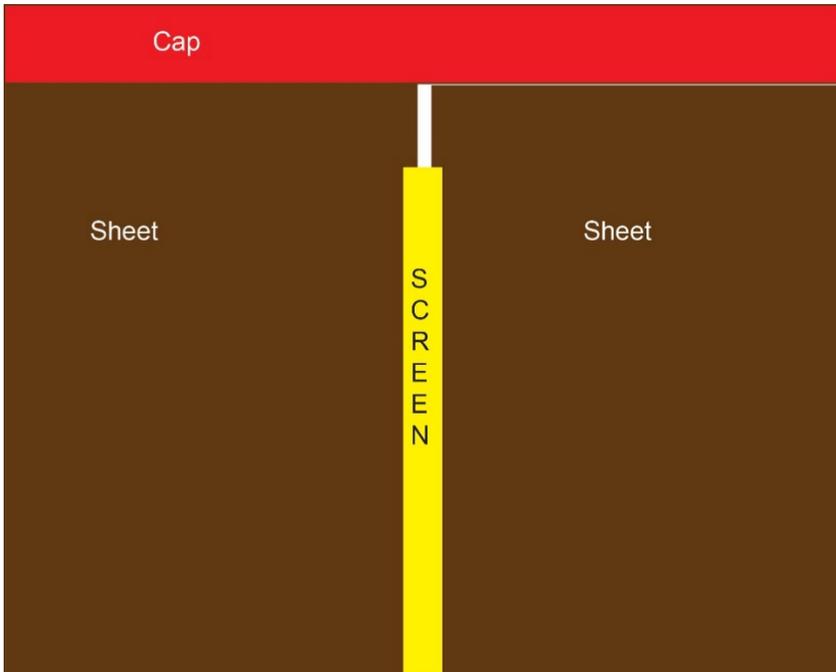
This second picture represents where two sheets join together, there is a screen behind the joint that lets the water drain but keeps the sand from washing out.

Every place two sheets butt together there is a screen behind it. This screen allows water to pass thru without the sand behind the sheet from washing into the canal. So once again, around 17,000 screens that occasionally have to be replaced.

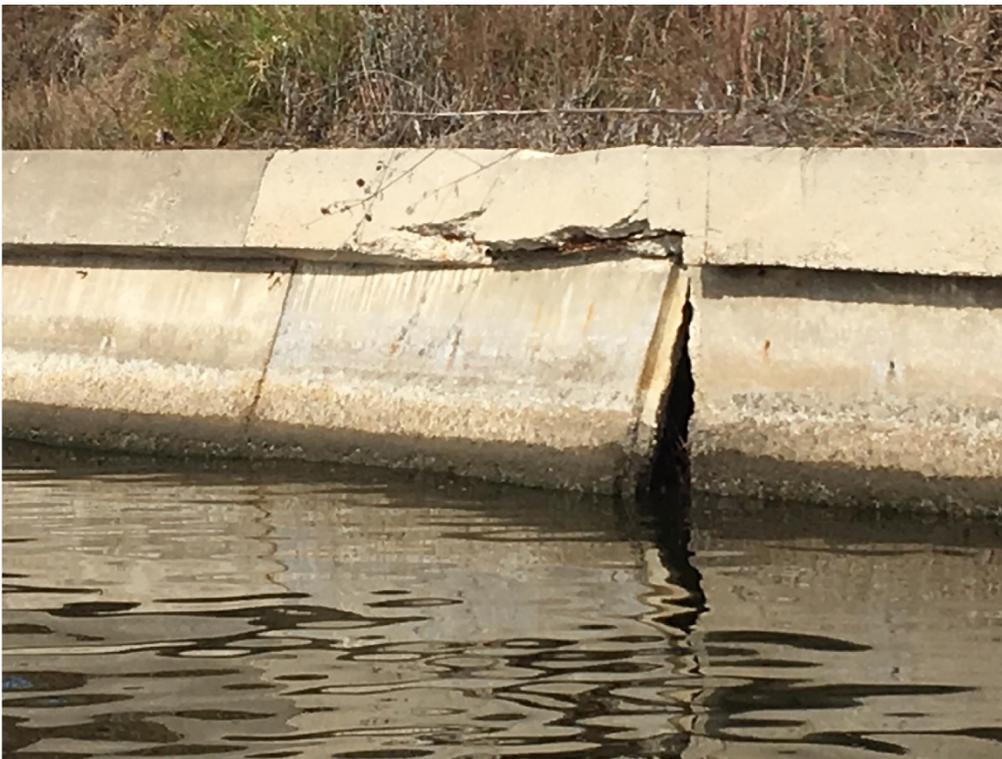
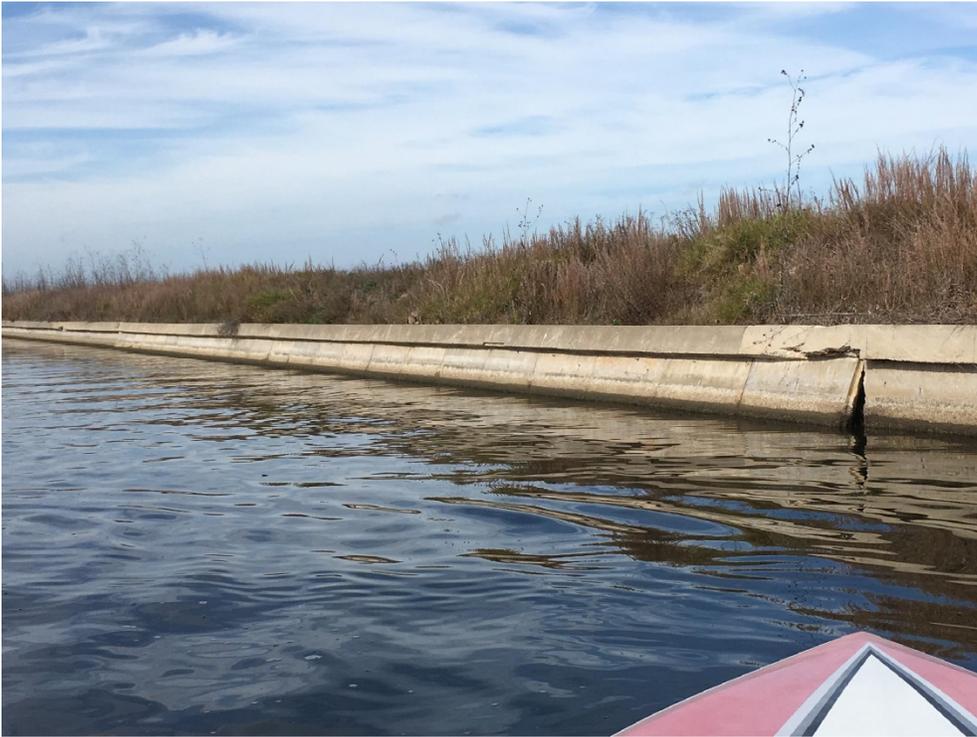
The next two pictures are of a larger bulkhead failure on the canal leading up to the German Bakery. This is the condition it is in today.

Tucked back out of the way it went unreported until recently. In addition to the obvious split sheet it looks like much of the area is now tilted and getting ready to collapse.

It looks like this failure might be considerably larger than the Primavera bulkhead project the POA just got done paying for, and we know those costs were in excess of \$4,000 per running foot. I understand the POA is currently investigating the repair approach and costs.
